# Access Compliance Report

## Public Rights-of-Way

### (Curb Ramps)

Main Street: VAN\_BUREN\_ST Cross Street: FLIGHT\_AVE Location: NE

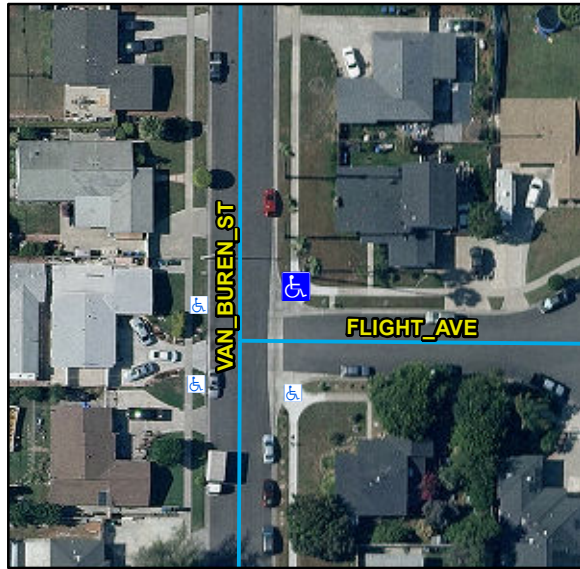
ADA ID: RPRK210930125221 Ramp Type: Type 1 - Perpendicular Diagonal Initial Pass/Fail: Fail Overall Compliance: No Severity Score: 2

| Compliance | Description | Data | Compliance | Description | Data |
|---|---|---|---|---|---|
| No | Ramp Cross Slope (%) | 4 | N/A | Flare Traversable LT | N/A |

Possible Solutions:

**Remove & Replace Curb Ramp With Two New Directional Ramps or Equivalent.**

**R304.5.3, STD 1115**
