# Access Compliance Report Public Rights-of-Way (Curb Ramps)

Main Street: MONROE\_ST Cross Street: PETERS\_AVE Location: NE

ADA ID: RPRK210930131607 Ramp Type: Type 1 - Perpendicular Diagonal Initial Pass/Fail: Fail Overall Compliance: No Severity Score: 16

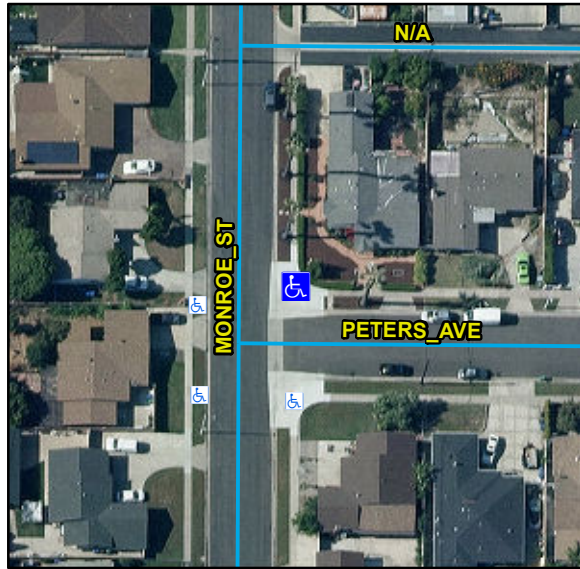
| Compliance | Description | Data | Compliance | Description | Data |
|---|---|---|---|---|---|
| No | Ramp Run Slope (%) | 8.8 | N/A | Flare Slope LT (%) | N/A |
| No | Ramp Cross Slope (%) | 4.2 | N/A | Flare Traversable LT | N/A |

**Remove & Replace Curb Ramp With Two New Directional Ramps or Equivalent.**

**R304.2.2, R304.5.3, STD 1115**
