# Access Compliance Report Public Rights-of-Way (Curb Ramps)

Main Street: PETERS\_AVE Cross Street: MONROE\_ST Location: SE

ADA ID: RPRK210930131753 Ramp Type: Type 1 - Perpendicular Diagonal Initial Pass/Fail: Fail Overall Compliance: No Severity Score: 15

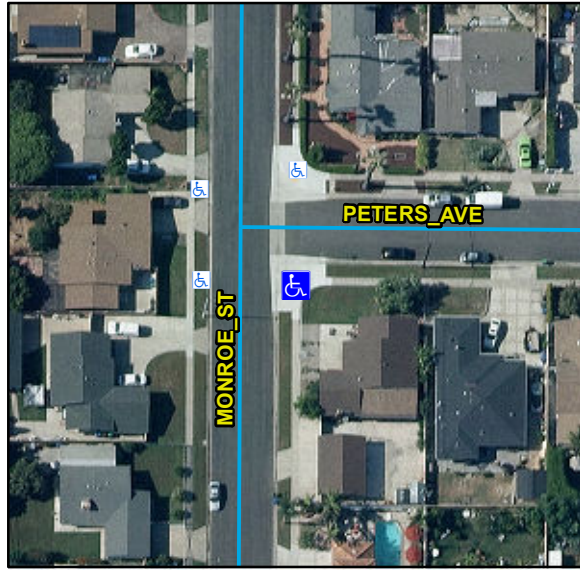
| Compliance | Description | Data | Compliance | Description | Data |
|---|---|---|---|---|---|
| No | Ramp Run Slope (%) | 10.5 | N/A | Flare Slope LT (%) | N/A |

**Remove & Replace Curb Ramp With Two New Directional Ramps or Equivalent.**

**R304.2.2, STD 1115**
