# Access Compliance Report Public Rights-of-Way (Curb Ramps)

Main Street: **MONROE\_ST** Cross Street: **FLIGHT\_AVE** Location: **NE**

ADA ID: **RPRK210930132104** Ramp Type: **Type 1 - Perpendicular Diagonal Initial Pass/Fail: Pass** Overall Compliance: **No** Severity Score: **9**

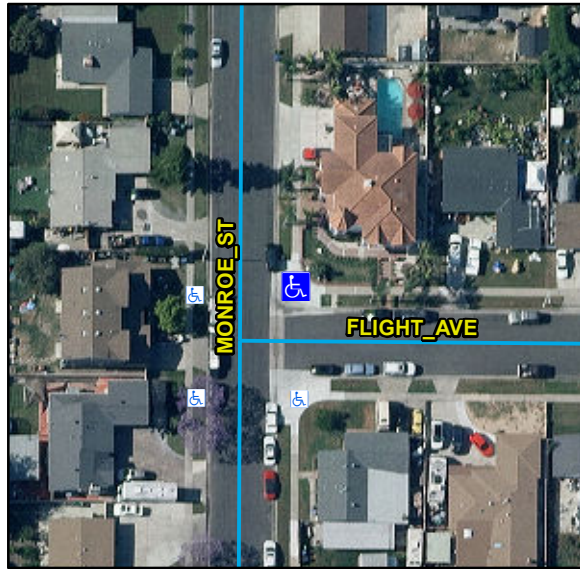
| Compliance | Description | Data | Compliance | Description | Data |
|---|---|---|---|---|---|
| <b>No</b> | Gutter Run Slope (%) | <b>9.8</b> | | Road Cross Slope (%) | <b>7.1</b> |
| <b>No</b> | Gutter Cross Slope (%) | <b>3.4</b> | | | |

**Remove & Replace Landing. Remove & Replace Gutter.**

**R304.2.1, R304.5.4, R304.5.3, STD 1115**
