# Access Compliance Report Public Rights-of-Way (Curb Ramps)

Main Street: WASHINGTON\_AVE Cross Street: ADAMS\_ST Location: SE

ADA ID: RPRK210930141752 Ramp Type: Type 1 - Perpendicular Diagonal Initial Pass/Fail: Fail Overall Compliance: No Severity Score: 15

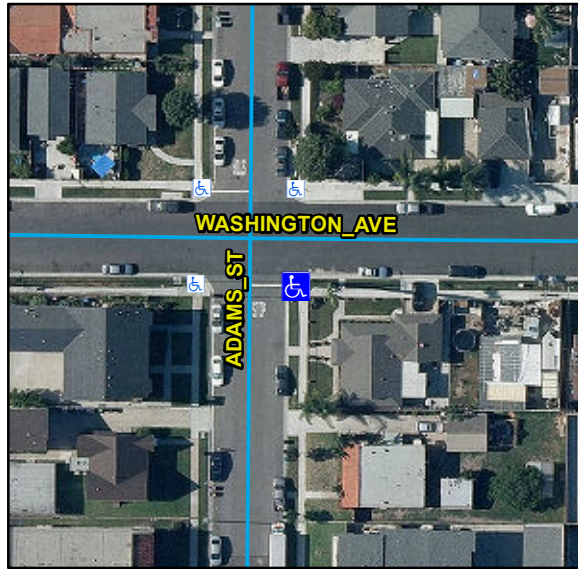
| Compliance | Description | Data | Compliance | Description | Data |
|---|---|---|---|---|---|
| No | Ramp Run Slope (%) | 10.6 | N/A | Flare Slope LT (%) | N/A |
| N/A | Gutter Ponding | N/A | No | Curb Slope | 11.4 |

Remove & Replace Curb Ramp With Two New Directional Ramps or Equivalent.

R304.2.2, R204.3, STD 1115
