# Access Compliance Report Public Rights-of-Way (Curb Ramps)

Main Street: ADAMS\_ST Cross Street: WASHINGTON\_AVE Location: SW

ADA ID: RPRK210930142441 Ramp Type: Type 1 - Perpendicular Diagonal Initial Pass/Fail: Pass Overall Compliance: No Severity Score: 4

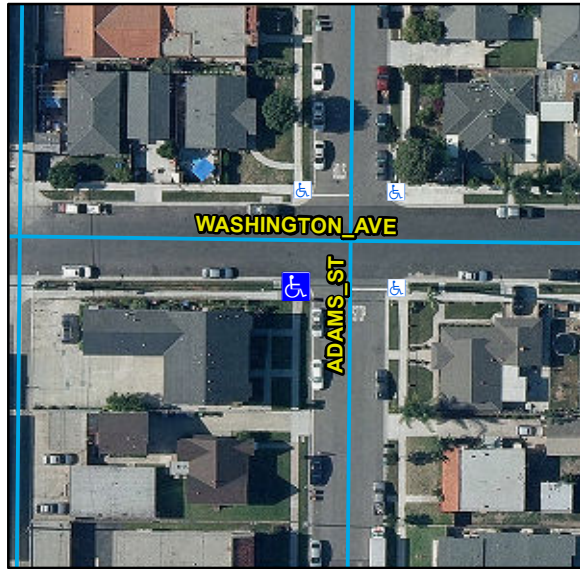
| Compliance | Description | Data | Compliance | Description | Data |
|---|---|---|---|---|---|
| No | Landing Run Slope (%) | 4.9 | N/A | Flare Traversable RT | No |

Remove & Replace Curb Ramp With Two New Directional Ramps or Equivalent.
