# Access Compliance Report Public Rights-of-Way (Curb Ramps)

Main Street: WASHINGTON\_AVE Cross Street: ADAMS\_ST Location: NW

ADA ID: RPRK210930143442 Ramp Type: Type 1 - Perpendicular Diagonal Initial Pass/Fail: Fail Overall Compliance: No Severity Score: 2

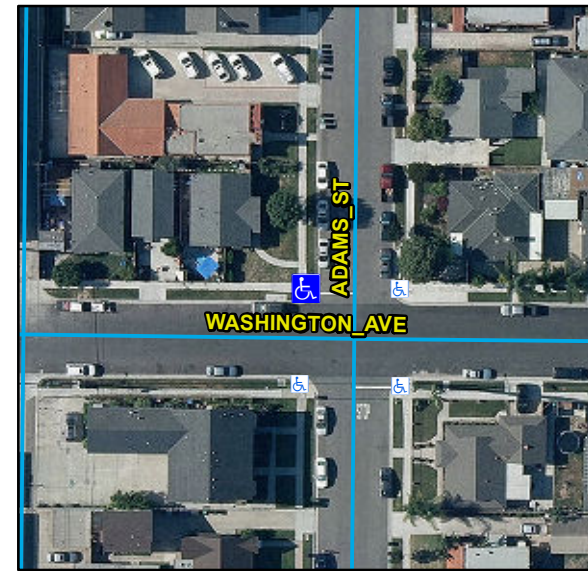
| Compliance | Description | Data | Compliance | Description | Data |
|---|---|---|---|---|---|
| No | Ramp Cross Slope (%) | 2.4 | N/A | Flare Traversable LT | N/A |

Remove & Replace Curb Ramp With Two New Directional Ramps or Equivalent.

R304.2.2, R204.3, R304.5.3, STD 1115
