# Access Compliance Report Public Rights-of-Way (Curb Ramps)

Main Street: ADAMS\_ST Cross Street: WASHINGTON\_AVE Location: NE

ADA ID: RPRK210930144032 Ramp Type: Type 1 - Perpendicular Diagonal Initial Pass/Fail: Fail Overall Compliance: No Severity Score: 15

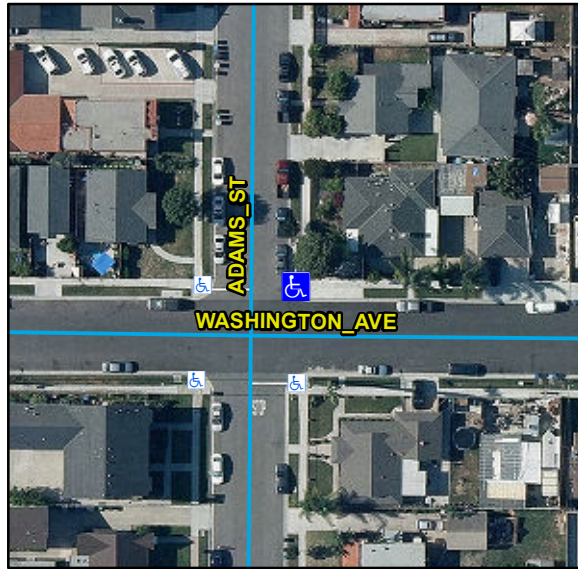
| Compliance | Description | Data | Compliance | Description | Data |
|---|---|---|---|---|---|
| No | Ramp Run Slope (%) | 11.2 | N/A | Flare Slope LT (%) | N/A |

Remove & Replace Curb Ramp With Two New Directional Ramps or Equivalent.

R304.2.2, R204.3, STD 1115
