# Access Compliance Report Public Rights-of-Way (Curb Ramps)

Main Street: WASHINGTON\_AVE Cross Street: JACKSON\_ST Location: NW

ADA ID: RPRK210930150751 Ramp Type: Type 1 - Perpendicular Diagonal Initial Pass/Fail: Fail Overall Compliance: No Severity Score: 20

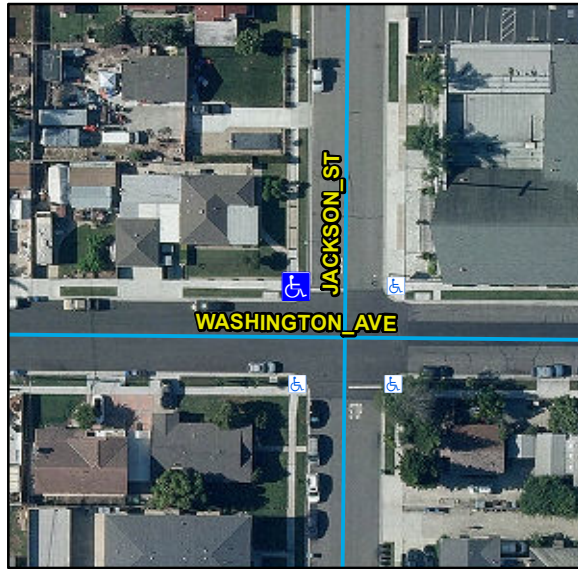
| Compliance | Description | Data | Compliance | Description | Data |
|---|---|---|---|---|---|
| No | Ramp Width (in) | 36 | | | N/A |
| No | Ramp Run Slope (%) | 9.6 | N/A | Flare Slope LT (%) | N/A |
| No | Ramp Cross Slope (%) | 3.7 | N/A | Flare Traversable LT | N/A |

**Remove & Replace Curb Ramp With Two New Directional Ramps or Equivalent.**

**R304.2.2, R204.3, R304.5.1, R304.5.3, STD 1115**
