# Access Compliance Report Public Rights-of-Way (Curb Ramps)

Main Street: JACKSON\_ST Cross Street: WASHINGTON\_AVE Location: NE

ADA ID: RPRK210930151428 Ramp Type: Type 1 - Perpendicular Diagonal Initial Pass/Fail: Fail Overall Compliance: No Severity Score: 19

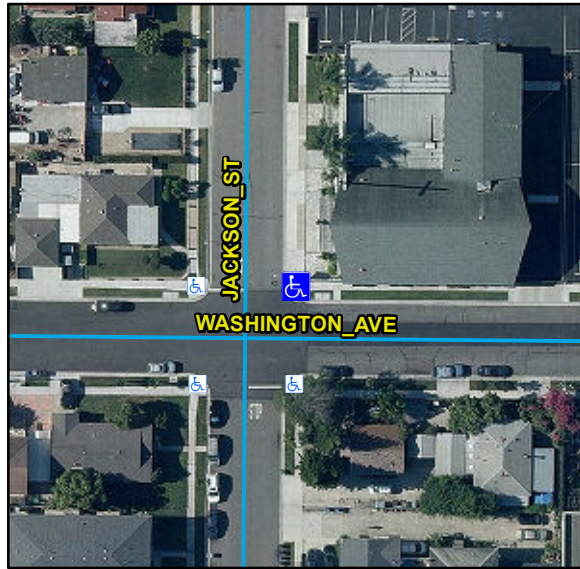
| Compliance | Description | Data | Compliance | Description | Data |
|---|---|---|---|---|---|
| No | Ramp Width (in) | 36 | | | N/A |
| No | Ramp Run Slope (%) | 10.2 | N/A | Flare Slope LT (%) | N/A |

Remove & Replace Curb Ramp With Two New Directional Ramps or Equivalent.
