# Access Compliance Report Public Rights-of-Way (Curb Ramps)

Main Street: WASHINGTON\_AVE Cross Street: JACKSON\_ST Location: SE

ADA ID: RPRK210930152253 Ramp Type: Type 1 - Perpendicular Diagonal Initial Pass/Fail: Fail Overall Compliance: No Severity Score: 19

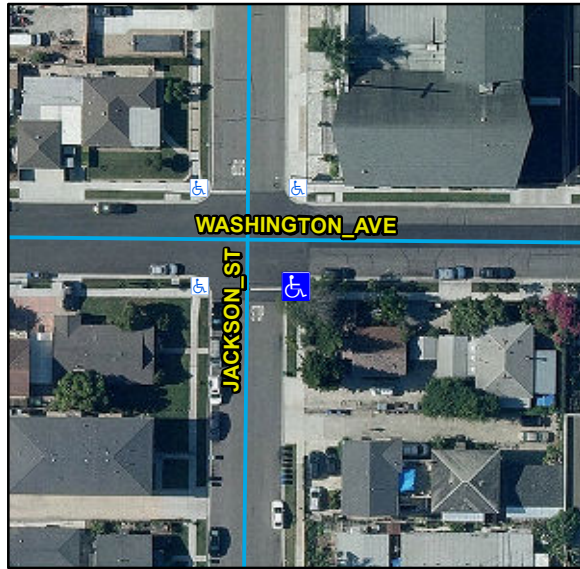
| Compliance | Description | Data | Compliance | Description | Data |
|---|---|---|---|---|---|
| No | Ramp Width (in) | 36 | | | N/A |
| No | Ramp Run Slope (%) | 11.5 | N/A | Flare Slope LT (%) | N/A |

Remove & Replace Curb Ramp With Two New Directional Ramps or Equivalent.
