# Access Compliance Report Public Rights-of-Way (Curb Ramps)

Main Street: JACKSON\_ST Cross Street: WASHINGTON\_AVE Location: SW

ADA ID: RPRK210930153018 Ramp Type: Type 1 - Perpendicular Diagonal Initial Pass/Fail: Fail Overall Compliance: No Severity Score: 19

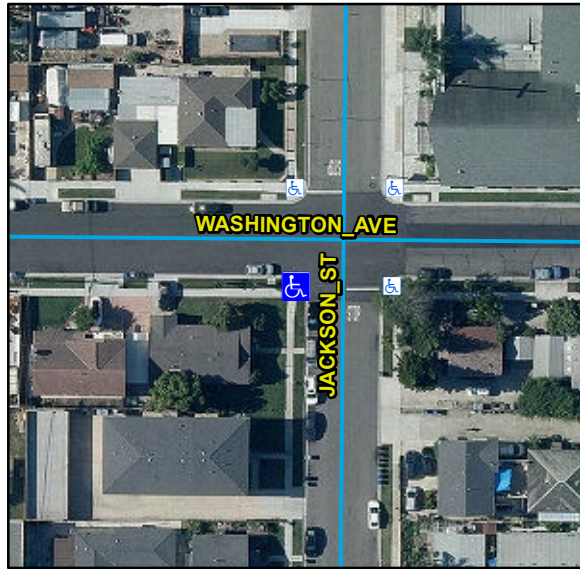
| Compliance | Description | Data | Compliance | Description | Data |
|---|---|---|---|---|---|
| No | Ramp Width (in) | 36 | | | N/A |
| No | Ramp Run Slope (%) | 11.3 | N/A | Flare Slope LT (%) | N/A |

**Remove & Replace Curb Ramp With Two New Directional Ramps or Equivalent.**

**R304.2.2, R204.3, R304.5.1, STD 1115**
