# Access Compliance Report Public Rights-of-Way (Curb Ramps)

| Main Street: WASHINGTON_AVE | | Cross Street: VAN_BUREN_ST | | Location: | NW |
| ADA ID: RPRK210930154027 | Ramp Type:Type 1 - Perpendicular Diagonal Initial Pass/Fail: Fail | | Overall Compliance: No | Severity Score: | 20 |

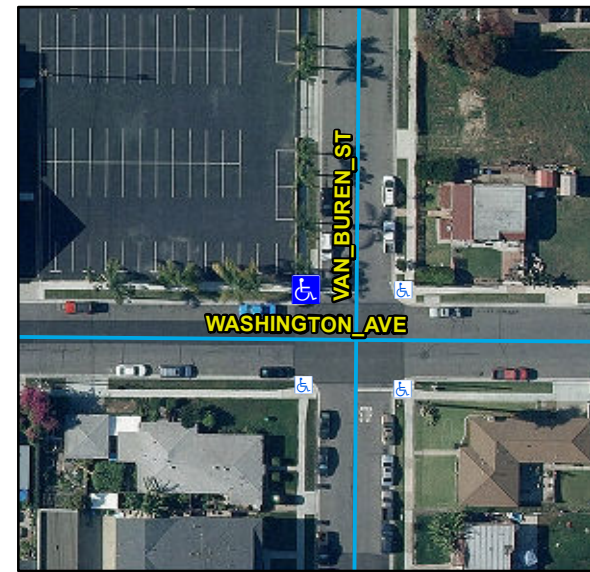
| Compliance | Description | Data | Compliance | Description | Data |
|---|---|---|---|---|---|
| No | Ramp Width (in) | 36 | | | N/A |
| No | Ramp Run Slope (%) | 11.9 | N/A | Flare Slope LT (%) | N/A |
| No | Ramp Cross Slope (%) | 2.6 | N/A | Flare Traversable LT | N/A |

**Remove & Replace Curb Ramp With Two New Directional Ramps or Equivalent.**

**R304.2.2, R204.3, R304.5.1, R304.5.3, STD 1115**
