# Access Compliance Report

## Public Rights-of-Way

### (Curb Ramps)

Main Street: VAN\_BUREN\_ST Cross Street: WASHINGTON\_AVE Location: NE

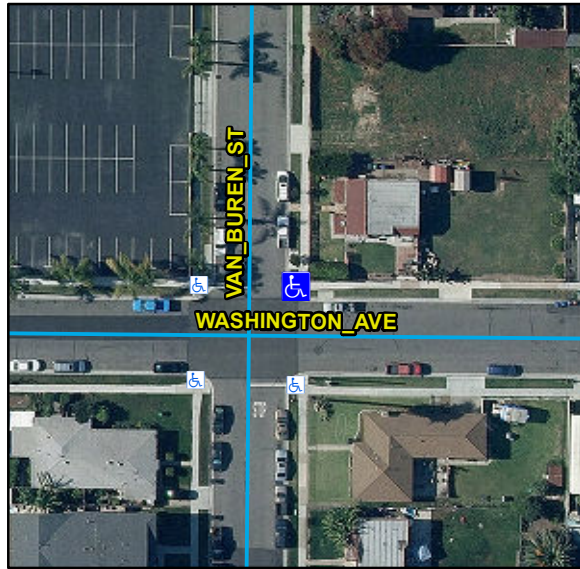
ADA ID: RPRK210930165755 Ramp Type: Type 1 - Perpendicular Diagonal Initial Pass/Fail: Fail Overall Compliance: No Severity Score: 20

| Compliance | Description | Data | Compliance | Description | Data |
|---|---|---|---|---|---|
| No | Ramp Width (in) | 36 | | | N/A |
| No | Ramp Run Slope (%) | 9.9 | N/A | Flare Slope LT (%) | N/A |
| No | Ramp Cross Slope (%) | 2.3 | N/A | Flare Traversable LT | N/A |

**Remove & Replace Curb Ramp With Two New Directional Ramps or Equivalent.**

**R304.2.2, R204.3, R304.5.1, R304.5.3, STD 1115**
