# Access Compliance Report Public Rights-of-Way (Curb Ramps)

**Main Street:** VAN\_BUREN\_ST      **Cross Street:** WASHINGTON\_AVE      **Location:** SE

**ADA ID:** RPRK210930170443      **Ramp Type:** Type 1 - Perpendicular Diagonal Initial Pass/Fail: Fail      **Overall Compliance:** No      **Severity Score:** 19

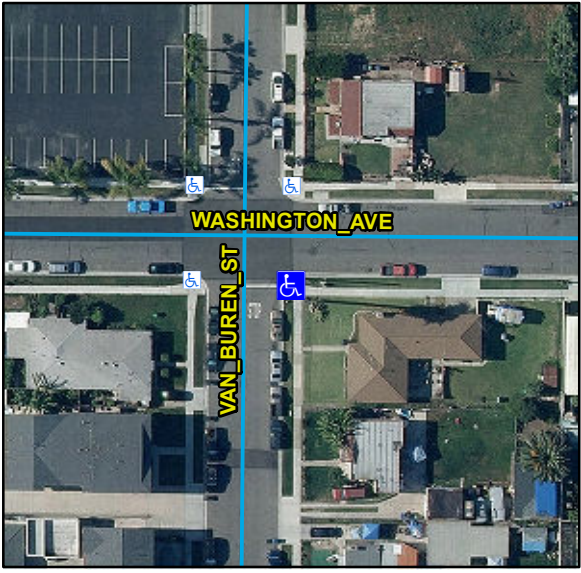
Compliance	Description	Data	Compliance	Description	Data
N/A	Ramp Length (in)	105	N/A	Flare Type LT	
No	Ramp Width (in)	36			N/A
No	Ramp Run Slope (%)	10.2	N/A	Flare Slope LT (%)	N/A
Yes	Ramp Cross Slope (%)	1.6	N/A	Flare Traversable LT	N/A
N/A	Landing Present	N/A	N/A	Flare Type RT	
N/A	Landing Length (in)	N/A			N/A
N/A	Landing Width (in)	N/A	N/A	Flare Slope RT (%)	N/A
N/A	Landing Run Slope (%)	N/A	N/A	Flare Traversable RT	N/A
N/A	Landing Cross Slope (%)	N/A	N/A	DWS Provided	N/A
N/A	Landing Movement Obstructed?	N/A	N/A	DWS Contrast	N/A
	Landing Movement Type	N/A	N/A	DWS Length (in)	N/A
N/A	Landing Shared	N/A	N/A	DWS Full Width	N/A
N/A	Clear Space	Yes	N/A	DWS Offset Left (in)	N/A
N/A	Clear Space To Crosswalk (in)	N/A	N/A	DWS Offset Right (in)	N/A
N/A	Marked Crosswalk 1	No	N/A	Marked Crosswalk 2	No
	Crossing 1 Direction	N		Crossing 2 Direction	W
	Marked Crosswalk 1 Width (in)	N/A		Marked Crosswalk 2 Width (in)	N/A

N/A	Ramp Inside Crosswalk 1	N/A	Yes	Ramp Inside Crosswalk 2	N/A
	Crossing 1 Slope (%)	6.9		Crossing 2 Slope (%)	1.4
	Crossing 1 Cross Slope (%)	3.2		Crossing 2 Cross Slope (%)	1.6
N/A	Gutter Ponding	N/A	N/A	Curb Slope	2.2
Yes	Gutter Lip Height (in)	0		Road Run Slope (%)	1.9
N/A	Gutter Run Slope (%)	N/A		Road Cross Slope (%)	6.8
N/A	Gutter Cross Slope (%)	N/A			
Yes	Overall Surface Condition:	Acceptable	No	Perp Joint Present	No
	Cross Gutter Present?	No		Spandrel Present?	No
	Replace Cross Gutter?	N/A		Replace Spandrel?	N/A

**Possible Solutions:**  
**Remove & Replace Curb Ramp With Two New Directional Ramps or Equivalent.**
