# Access Compliance Report Public Rights-of-Way (Curb Ramps)

Main Street: VAN\_BUREN\_ST Cross Street: WASHINGTON\_AVE Location: SW

ADA ID: RPRK210930171111 Ramp Type: Type 1 - Perpendicular Diagonal Initial Pass/Fail: Fail Overall Compliance: No Severity Score: 19

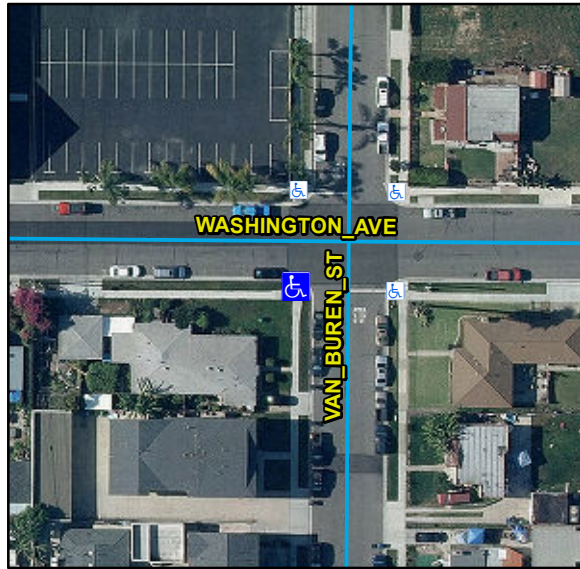
| Compliance | Description | Data | Compliance | Description | Data |
|---|---|---|---|---|---|
| No | Ramp Width (in) | 36 | | | N/A |
| No | Ramp Run Slope (%) | 11.1 | N/A | Flare Slope LT (%) | N/A |

**Remove & Replace Curb Ramp With Two New Directional Ramps or Equivalent.**
