# Access Compliance Report Public Rights-of-Way (Curb Ramps)

Main Street: MONROE\_ST Cross Street: WASHINGTON\_AVE Location: SW

ADA ID: RPRK210930172001 Ramp Type: Type 1 - Perpendicular Diagonal Initial Pass/Fail: Fail Overall Compliance: No Severity Score: 19

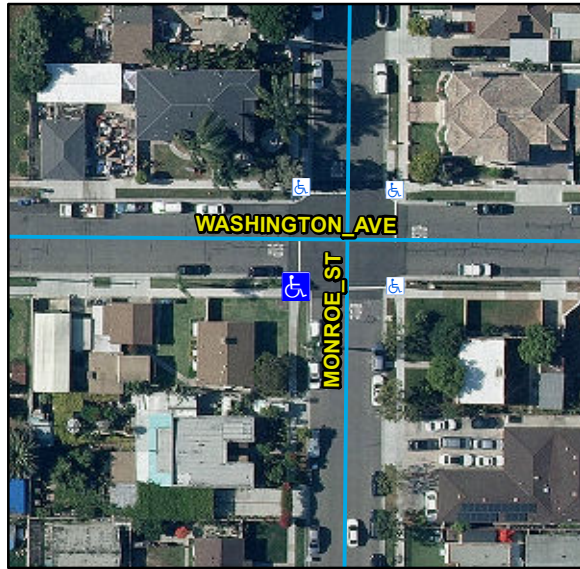
| Compliance | Description | Data | Compliance | Description | Data |
|---|---|---|---|---|---|
| No | Ramp Width (in) | 36 | | | N/A |
| No | Ramp Run Slope (%) | 11.1 | N/A | Flare Slope LT (%) | N/A |

**Remove & Replace Curb Ramp With Two New Directional Ramps or Equivalent.**

**R304.2.2, R204.3, R304.5.1, STD 1115**
