# Access Compliance Report Public Rights-of-Way (Curb Ramps)

Main Street: WASHINGTON\_AVE Cross Street: MONROE\_ST Location: NW

ADA ID: RPRK210930172853 Ramp Type: Type 1 - Perpendicular Diagonal Initial Pass/Fail: Fail Overall Compliance: No Severity Score: 5

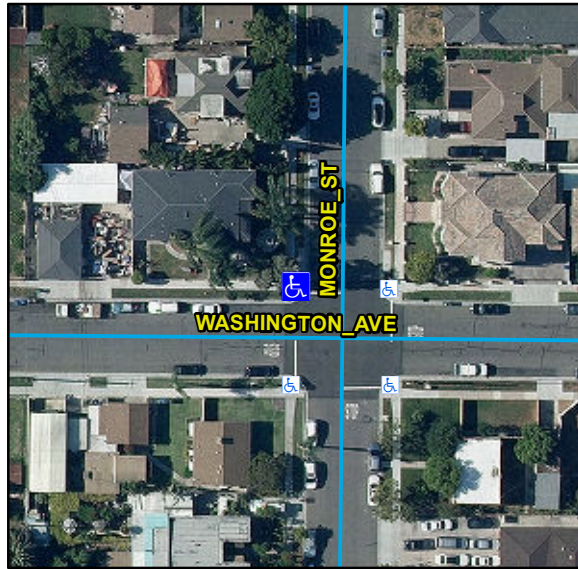
R304.2.2, R204.3, R304.5.1, R304.5.3, STD 1115

| Compliance | Description | Data | Compliance | Description | Data |
|---|---|---|---|---|---|
| No | Ramp Width (in) | 36 | | | N/A |
| No | Ramp Cross Slope (%) | 3.4 | N/A | Flare Traversable LT | N/A |

Remove & Replace Curb Ramp With Two New Directional Ramps or Equivalent.
