# Access Compliance Report Public Rights-of-Way (Curb Ramps)

Main Street: MONROE\_ST Cross Street: WASHINGTON\_AVE Location: NE

ADA ID: RPRK210930173616 Ramp Type: Type 1 - Perpendicular Diagonal Initial Pass/Fail: Fail Overall Compliance: No Severity Score: 19

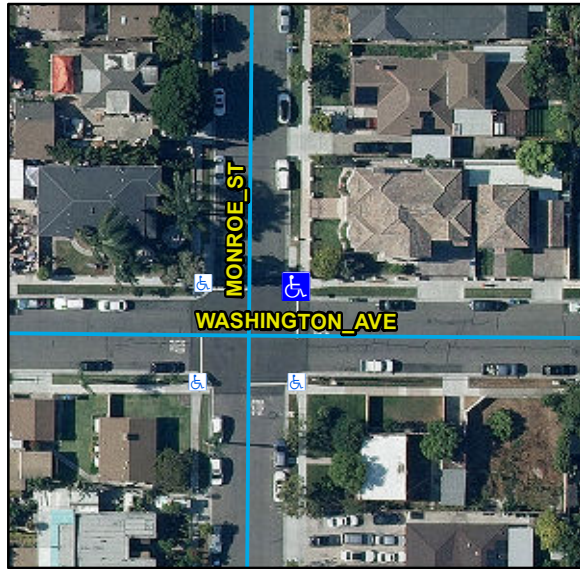
| Compliance | Description | Data | Compliance | Description | Data |
|---|---|---|---|---|---|
| No | Ramp Width (in) | 36 | | | N/A |
| No | Ramp Run Slope (%) | 11.9 | N/A | Flare Slope LT (%) | N/A |

**Remove & Replace Curb Ramp With Two New Directional Ramps or Equivalent.**

**R304.2.2, R204.3, R304.5.1, STD 1115**
