# Access Compliance Report Public Rights-of-Way (Curb Ramps)

Main Street: MONROE\_ST Cross Street: WASHINGTON\_AVE Location: SE

ADA ID: RPRK210930174218 Ramp Type: Type 1 - Perpendicular Diagonal Initial Pass/Fail: Fail Overall Compliance: No Severity Score: 34

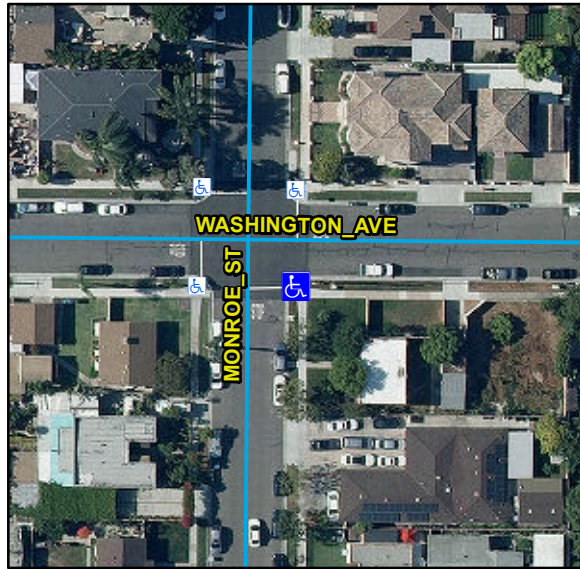
| Compliance | Description | Data | Compliance | Description | Data |
|---|---|---|---|---|---|
| No | Ramp Width (in) | 36 | | | N/A |
| No | Ramp Run Slope (%) | 9.8 | N/A | Flare Slope LT (%) | N/A |
| No | Overall Surface Condition: | Poor | No | Perp Joint Present | No |

**Remove & Replace Curb Ramp With Two New Directional Ramps or Equivalent.**
