# Access Compliance Report Public Rights-of-Way (Curb Ramps)

Main Street: WASHINGTON\_AVE Cross Street: JEFFERSON\_ST Location: SE

ADA ID: RPRK210930175301 Ramp Type: Type 1 - Perpendicular Diagonal Initial Pass/Fail: Fail Overall Compliance: No Severity Score: 19

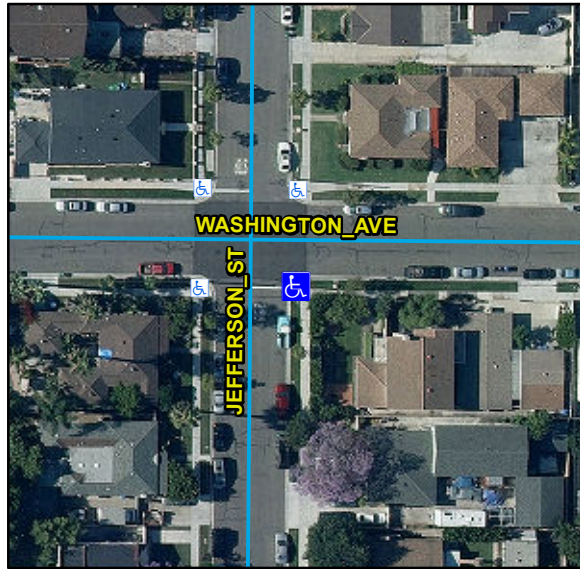
| Compliance | Description | Data | Compliance | Description | Data |
|---|---|---|---|---|---|
| No | Ramp Width (in) | 36 | | | N/A |
| No | Ramp Run Slope (%) | 11.5 | N/A | Flare Slope LT (%) | N/A |

Remove & Replace Curb Ramp With Two New Directional Ramps or Equivalent.
