# Access Compliance Report Public Rights-of-Way (Curb Ramps)

Main Street: JEFFERSON\_ST Cross Street: WASHINGTON\_AVE Location: NE

ADA ID: RPRK210930180332 Ramp Type: Type 1 - Perpendicular Diagonal Initial Pass/Fail: Fail Overall Compliance: No Severity Score: 19

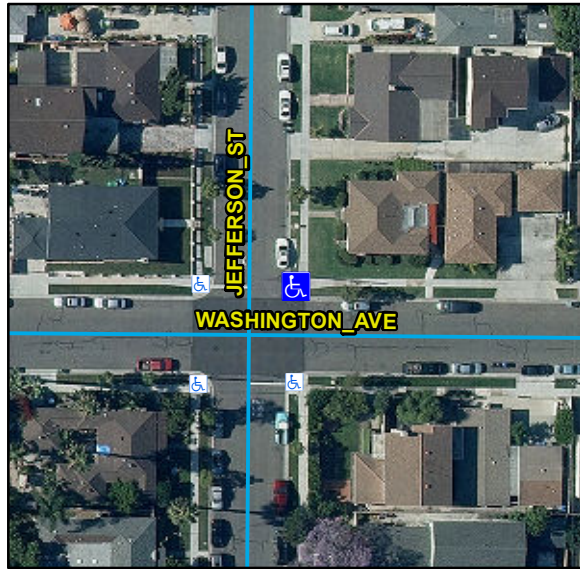
| Compliance | Description | Data | Compliance | Description | Data |
|---|---|---|---|---|---|
| No | Ramp Width (in) | 36 | | | N/A |
| No | Ramp Run Slope (%) | 11.5 | N/A | Flare Slope LT (%) | N/A |

Remove & Replace Curb Ramp With Two New Directional Ramps or Equivalent.

R304.2.2, R204.3, R304.5.1, STD 1115
