# Access Compliance Report Public Rights-of-Way (Curb Ramps)

Main Street: WASHINGTON\_AVE Cross Street: JEFFERSON\_ST Location: NW

ADA ID: RPRK210930181110 Ramp Type: Type 1 - Perpendicular Diagonal Initial Pass/Fail: Fail Overall Compliance: No Severity Score: 20

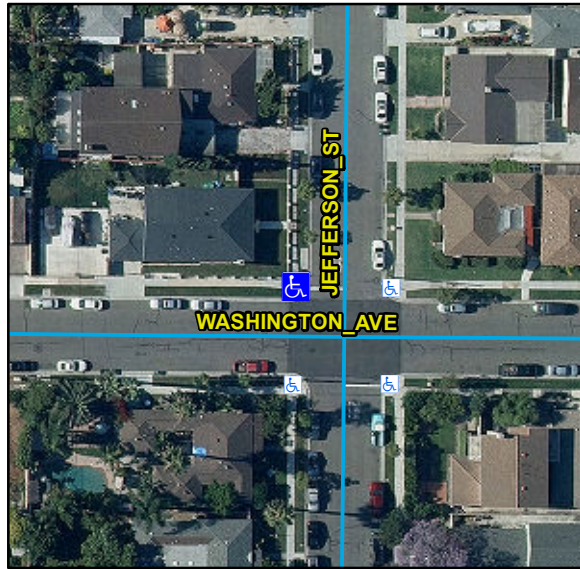
| Compliance | Description | Data | Compliance | Description | Data |
|---|---|---|---|---|---|
| No | Ramp Width (in) | 36 | | | N/A |
| No | Ramp Run Slope (%) | 10.3 | N/A | Flare Slope LT (%) | N/A |
| No | Ramp Cross Slope (%) | 2.1 | N/A | Flare Traversable LT | N/A |

**Remove & Replace Curb Ramp With Two New Directional Ramps or Equivalent.**

**R304.2.2, R204.3, R304.5.1, R304.5.3, STD 1115**
