# Access Compliance Report Public Rights-of-Way (Curb Ramps)

Main Street: JEFFERSON\_ST Cross Street: WASHINGTON\_AVE Location: SW

ADA ID: RPRK210930181841 Ramp Type: Type 1 - Perpendicular Diagonal Initial Pass/Fail: Fail Overall Compliance: No Severity Score: 20

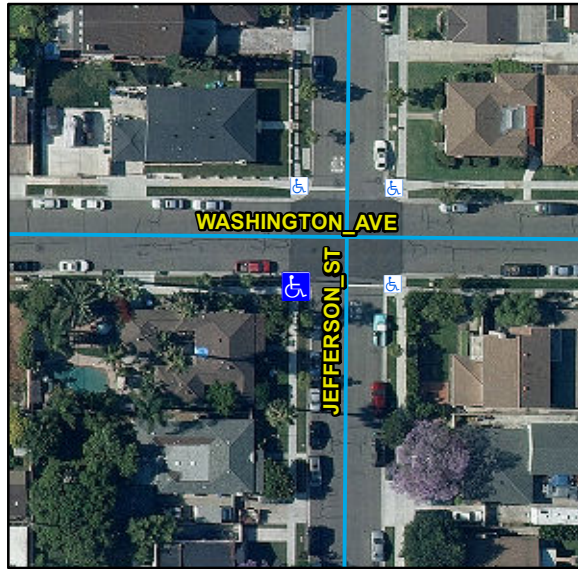
| Compliance | Description | Data | Compliance | Description | Data |
|---|---|---|---|---|---|
| No | Ramp Width (in) | 36 | | | N/A |
| No | Ramp Run Slope (%) | 10.9 | N/A | Flare Slope LT (%) | N/A |
| No | Ramp Cross Slope (%) | 2.5 | N/A | Flare Traversable LT | N/A |

Remove & Replace Curb Ramp With Two New Directional Ramps or Equivalent.
