Access Compliance Report Public Rights-of-Way (Curb Ramps)

Main Street: WASHINGTON_AVE **Cross Street:** WILSON_ST **Location:** NW

ADA ID: RPRK210930183104 **Ramp Type:** Type 1 - Perpendicular Diagonal Initial Pass/Fail: Fail **Overall Compliance:** No **Severity Score:** 20

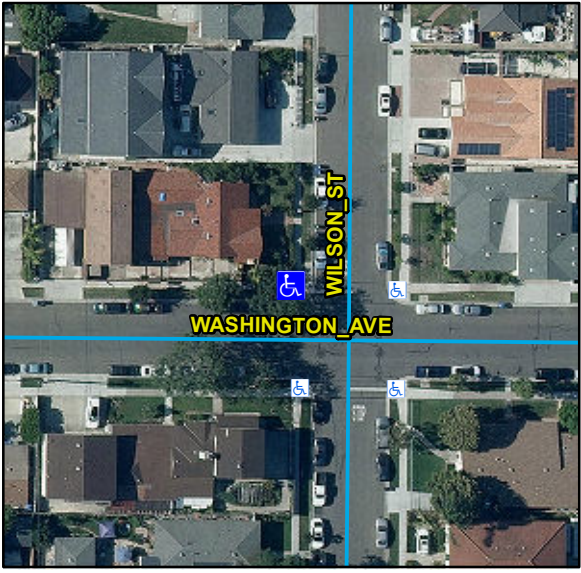
Compliance	Description	Data	Compliance	Description	Data
N/A	Ramp Length (in)	105	N/A	Flare Type LT	
No	Ramp Width (in)	36			N/A
No	Ramp Run Slope (%)	10.9	N/A	Flare Slope LT (%)	N/A
No	Ramp Cross Slope (%)	2.9	N/A	Flare Traversable LT	N/A
N/A	Landing Present	N/A	N/A	Flare Type RT	
N/A	Landing Length (in)	N/A			N/A
N/A	Landing Width (in)	N/A	N/A	Flare Slope RT (%)	N/A
N/A	Landing Run Slope (%)	N/A	N/A	Flare Traversable RT	N/A
N/A	Landing Cross Slope (%)	N/A	N/A	DWS Provided	N/A
N/A	Landing Movement Obstructed?	N/A	N/A	DWS Contrast	N/A
	Landing Movement Type	N/A	N/A	DWS Length (in)	N/A
N/A	Landing Shared	N/A	N/A	DWS Full Width	N/A
N/A	Clear Space	Yes	N/A	DWS Offset Left (in)	N/A
N/A	Clear Space To Crosswalk (in)	N/A	N/A	DWS Offset Right (in)	N/A
N/A	Marked Crosswalk 1	No	N/A	Marked Crosswalk 2	No
	Crossing 1 Direction	S		Crossing 2 Direction	E
	Marked Crosswalk 1 Width (in)	N/A		Marked Crosswalk 2 Width (in)	N/A

N/A	Ramp Inside Crosswalk 1	N/A	Yes	Ramp Inside Crosswalk 2	N/A
	Crossing 1 Slope (%)	6		Crossing 2 Slope (%)	1.2
	Crossing 1 Cross Slope (%)	0.8		Crossing 2 Cross Slope (%)	0.8
N/A	Gutter Ponding	N/A	N/A	Curb Slope	10.9
Yes	Gutter Lip Height (in)	0		Road Run Slope (%)	1.6
N/A	Gutter Run Slope (%)	N/A		Road Cross Slope (%)	0.1
N/A	Gutter Cross Slope (%)	N/A			
Yes	Overall Surface Condition: Acceptable		No	Perp Joint Present	No
	Cross Gutter Present?	No		Spandrel Present?	No
	Replace Cross Gutter?	N/A		Replace Spandrel?	N/A

Possible Solutions:
Remove & Replace Curb Ramp With Two New Directional Ramps or Equivalent.
