Access Compliance Report Public Rights-of-Way (Curb Ramps)

Main Street: WILSON_ST **Cross Street:** WASHINGTON_AVE **Location:** SW

ADA ID: RPRK210930183610 **Ramp Type:** Type 1 - Perpendicular Diagonal Initial Pass/Fail: Fail **Overall Compliance:** No **Severity Score:** 19

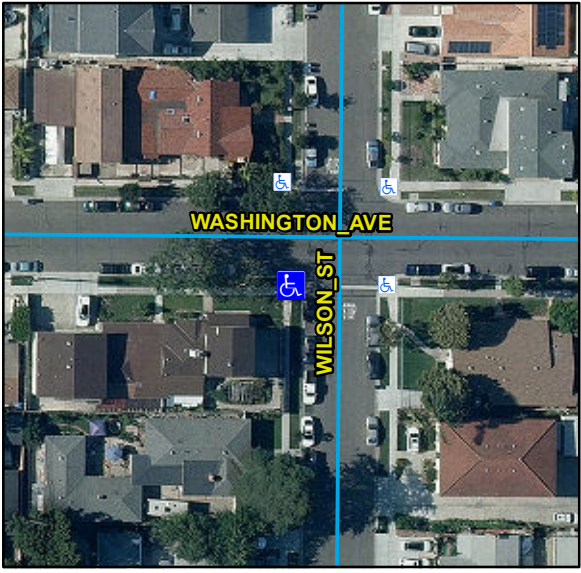
Compliance	Description	Data	Compliance	Description	Data
N/A	Ramp Length (in)	105	N/A	Flare Type LT	
No	Ramp Width (in)	36			N/A
No	Ramp Run Slope (%)	11.1	N/A	Flare Slope LT (%)	N/A
Yes	Ramp Cross Slope (%)	0.2	N/A	Flare Traversable LT	N/A
N/A	Landing Present	N/A	N/A	Flare Type RT	
N/A	Landing Length (in)	N/A			N/A
N/A	Landing Width (in)	N/A	N/A	Flare Slope RT (%)	N/A
N/A	Landing Run Slope (%)	N/A	N/A	Flare Traversable RT	N/A
N/A	Landing Cross Slope (%)	N/A	N/A	DWS Provided	N/A
N/A	Landing Movement Obstructed?	N/A	N/A	DWS Contrast	N/A
	Landing Movement Type	N/A	N/A	DWS Length (in)	N/A
N/A	Landing Shared	N/A	N/A	DWS Full Width	N/A
N/A	Clear Space	Yes	N/A	DWS Offset Left (in)	N/A
N/A	Clear Space To Crosswalk (in)	N/A	N/A	DWS Offset Right (in)	N/A
N/A	Marked Crosswalk 1	No	N/A	Marked Crosswalk 2	No
	Crossing 1 Direction	E		Crossing 2 Direction	N
	Marked Crosswalk 1 Width (in)	N/A		Marked Crosswalk 2 Width (in)	N/A

N/A	Ramp Inside Crosswalk 1	N/A	Yes	Ramp Inside Crosswalk 2	N/A
	Crossing 1 Slope (%)	4.7		Crossing 2 Slope (%)	1.1
	Crossing 1 Cross Slope (%)	1.8		Crossing 2 Cross Slope (%)	2.3
N/A	Gutter Ponding	N/A	No	Curb Slope	10.6
Yes	Gutter Lip Height (in)	0		Road Run Slope (%)	1.7
N/A	Gutter Run Slope (%)	N/A		Road Cross Slope (%)	2.3
N/A	Gutter Cross Slope (%)	N/A			
Yes	Overall Surface Condition: Acceptable		No	Perp Joint Present	No
	Cross Gutter Present?	No		Spandrel Present?	No
	Replace Cross Gutter?	N/A		Replace Spandrel?	N/A

Possible Solutions:
Remove & Replace Curb Ramp With Two New Directional Ramps or Equivalent.

OC Std/PROW:
R304.2.2, R204.3, R304.5.1, STD 1115
