# Access Compliance Report Public Rights-of-Way (Curb Ramps)

Main Street: WASHINGTON\_AVE Cross Street: WILSON\_ST Location: SE

ADA ID: RPRK211001110440 Ramp Type: Type 1 - Perpendicular Diagonal Initial Pass/Fail: Fail Overall Compliance: No Severity Score: 20

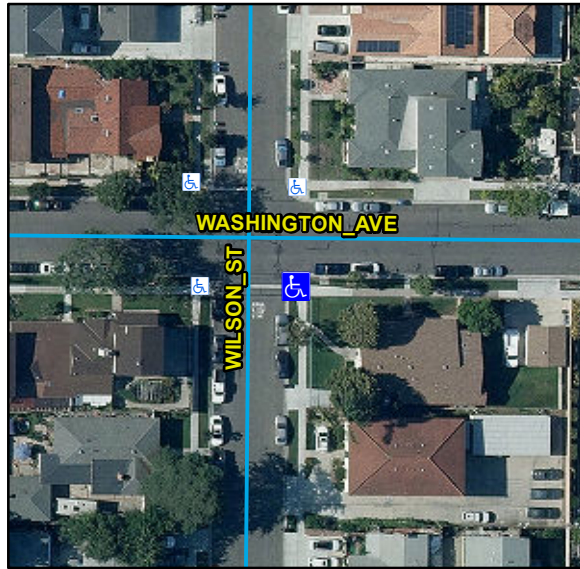
| Compliance | Description | Data | Compliance | Description | Data |
|---|---|---|---|---|---|
| No | Ramp Width (in) | 36 | | | N/A |
| No | Ramp Run Slope (%) | 10.5 | N/A | Flare Slope LT (%) | N/A |
| No | Ramp Cross Slope (%) | 2.5 | N/A | Flare Traversable LT | N/A |

Remove & Replace Curb Ramp With Two New Directional Ramps or Equivalent.

R304.2.2, R304.5.1, R304.5.3, STD 1115
