# Access Compliance Report Public Rights-of-Way (Curb Ramps)

Main Street: WILSON\_ST Cross Street: WASHINGTON\_AVE Location: NE

ADA ID: RPRK211001110937 Ramp Type: Type 1 - Perpendicular Diagonal Initial Pass/Fail: Pass Overall Compliance: No Severity Score: 4

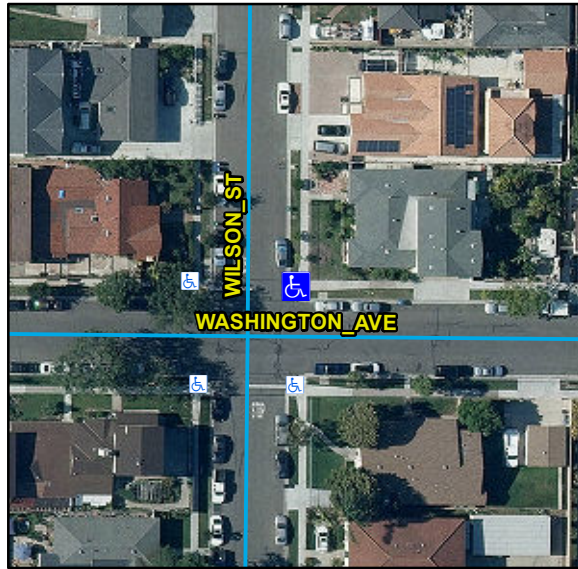
| Compliance | Description | Data | Compliance | Description | Data |
|---|---|---|---|---|---|
| Yes | Gutter Ponding | No | No | Curb Slope | 5.9 |
| No | Gutter Cross Slope (%) | 3.5 | | | |

Remove & Replace Curb Ramp With Two New Directional Ramps or Equivalent. Remove & Replace Gutter.
