# Access Compliance Report

## Public Rights-of-Way

### (Curb Ramps)

Main Street: WASHINGTON\_AVE Cross Street: HARPER\_ST Location: NW

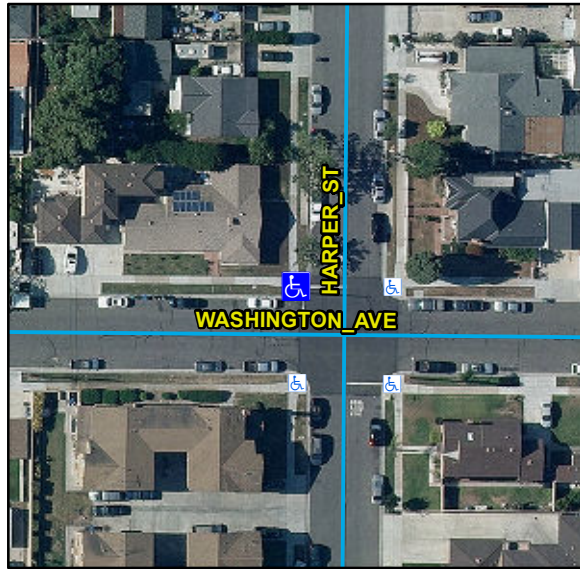
ADA ID: RPRK211001111721 Ramp Type: Type 1 - Perpendicular Diagonal Initial Pass/Fail: Pass Overall Compliance: No Severity Score: 10

| Compliance | Description | Data | Compliance | Description | Data |
|---|---|---|---|---|---|
| No | Landing Width (in) | 47 | N/A | Flare Slope RT (%) | 8.2 |
| No | Landing Cross Slope (%) | 2.2 | Yes | DWS Provided | Yes |
| No | Gutter Run Slope (%) | 9.3 | | Road Cross Slope (%) | 6.8 |

Possible Solutions:

**Remove & Replace Landing. Remove & Replace Gutter.**

**R304.2.1, R304.5.3, R304.5.4, STD 1115**

Total Cost: \$ 783
