# Access Compliance Report Public Rights-of-Way (Curb Ramps)

Main Street: HARPER\_ST Cross Street: WASHINGTON\_AVE Location: NE

ADA ID: RPRK211001112228 Ramp Type: Type 1 - Perpendicular Diagonal Initial Pass/Fail: Pass Overall Compliance: No Severity Score: 0

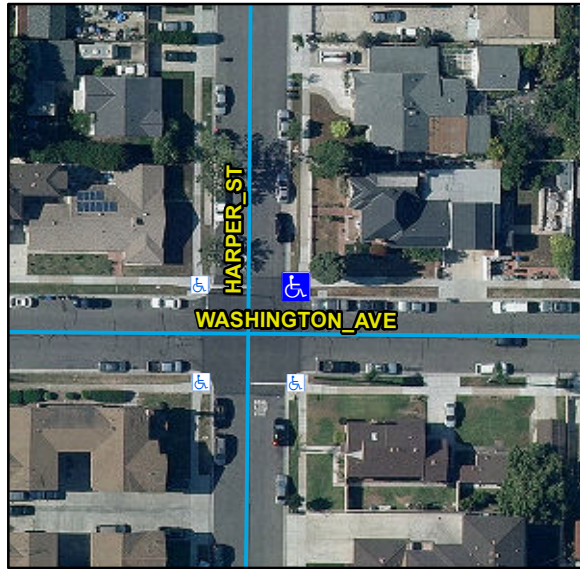
| Compliance | Description | Data | Compliance | Description | Data |
|---|---|---|---|---|---|
| No | Gutter Cross Slope (%) | 4 | | | |

**Remove & Replace Landing. Remove & Replace Gutter.**

**R304.2.1, R304.5.3, STD 1115**
