# Access Compliance Report Public Rights-of-Way (Curb Ramps)

Main Street: WASHINGTON\_AVE Cross Street: HARPER\_ST Location: SE

ADA ID: RPRK211001112903 Ramp Type: Type 1 - Perpendicular Diagonal Initial Pass/Fail: Fail Overall Compliance: No Severity Score: 2

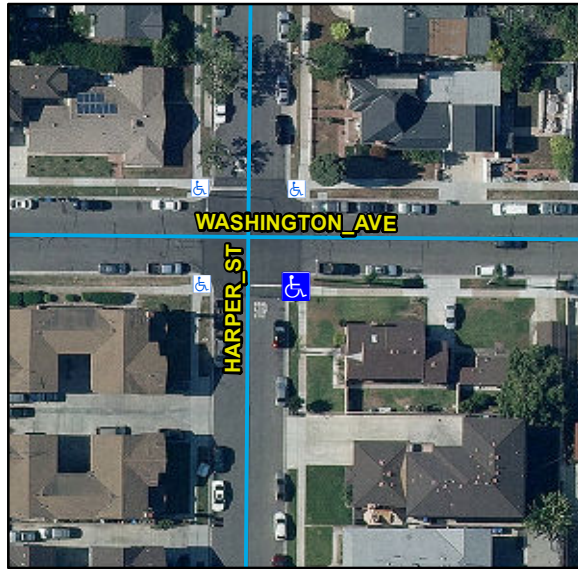
| Compliance | Description | Data | Compliance | Description | Data |
|---|---|---|---|---|---|
| No | Ramp Cross Slope (%) | 2.2 | N/A | Flare Traversable LT | N/A |

**Remove & Replace Curb Ramp With Two New Directional Ramps or Equivalent.**

**R304.5.3, STD 1115**
