# Access Compliance Report Public Rights-of-Way (Curb Ramps)

Main Street: HARPER\_ST Cross Street: WASHINGTON\_AVE Location: SW

ADA ID: RPRK211001113313 Ramp Type: Type 1 - Perpendicular Diagonal Initial Pass/Fail: Fail Overall Compliance: No Severity Score: 20

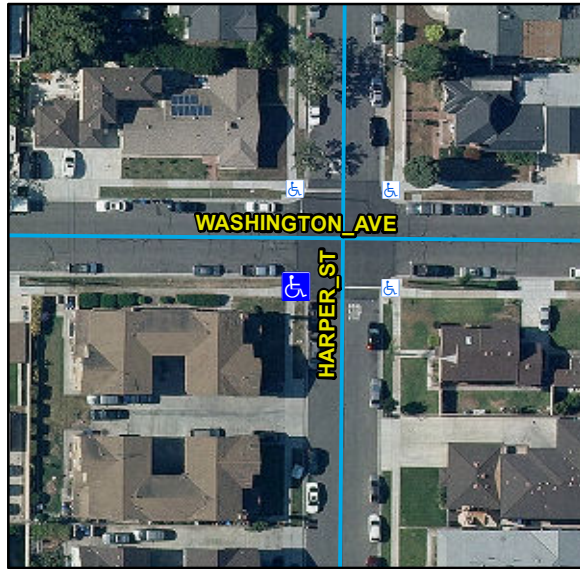
| Compliance | Description | Data | Compliance | Description | Data |
|---|---|---|---|---|---|
| No | Ramp Width (in) | 36 | | | N/A |
| No | Ramp Run Slope (%) | 11.5 | N/A | Flare Slope LT (%) | N/A |
| No | Ramp Cross Slope (%) | 2.1 | N/A | Flare Traversable LT | N/A |

Remove & Replace Curb Ramp With Two New Directional Ramps or Equivalent.

R304.2.2, R304.5.1, R304.5.3, STD 1115
