# Access Compliance Report Public Rights-of-Way (Curb Ramps)

Main Street: NEWLAND\_ST Cross Street: WASHINGTON\_AVE Location: SW

ADA ID: RPRK211001113927 Ramp Type: Type 1 - Perpendicular Diagonal Initial Pass/Fail: Fail Overall Compliance: No Severity Score: 2

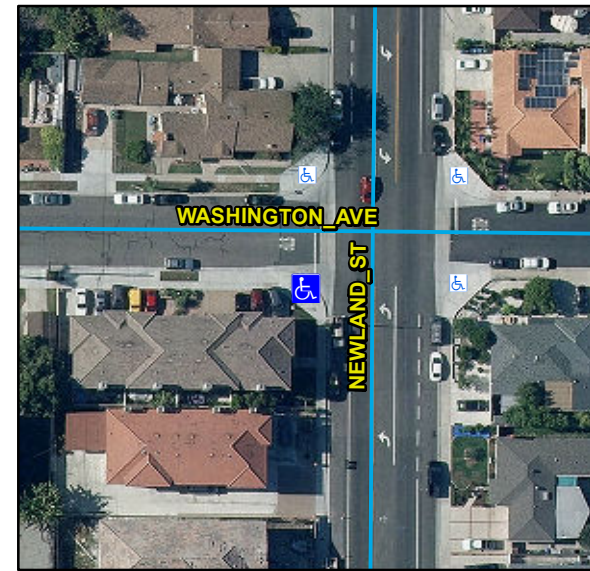
| Compliance | Description | Data | Compliance | Description | Data |
|---|---|---|---|---|---|
| No | Ramp Cross Slope (%) | 3.2 | N/A | Flare Traversable LT | N/A |

Possible Solutions:  
**Remove & Replace Curb Ramp With Two New Directional Ramps or Equivalent.**

OC Std/PROW:  
**R304.2.2, R304.5.3, STD 1115**
