# Access Compliance Report Public Rights-of-Way (Curb Ramps)

Main Street: WASHINGTON\_AVE Cross Street: NEWLAND\_ST Location: NW

ADA ID: RPRK211001114404 Ramp Type: Type 1 - Perpendicular Diagonal Initial Pass/Fail: Pass Overall Compliance: No Severity Score: 10

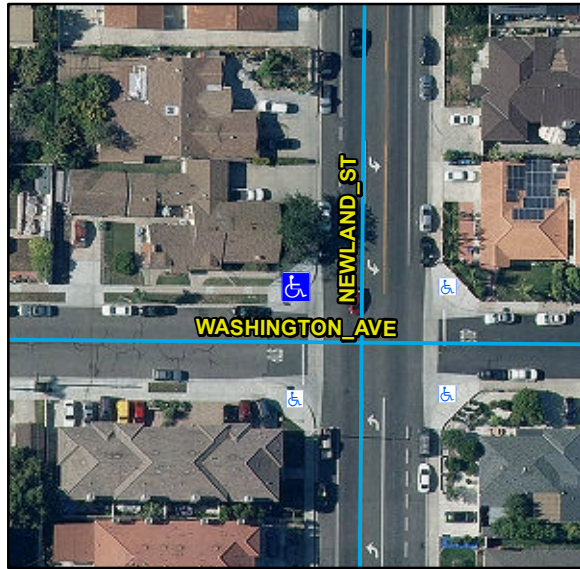
| Compliance | Description | Data | Compliance | Description | Data |
|---|---|---|---|---|---|
| Yes | Gutter Ponding | No | No | Curb Slope | 6.8 |
| No | Gutter Cross Slope (%) | 4.2 | | | |

Remove & Replace Curb Ramp With Two New Directional Ramps or Equivalent. Remove & Replace Gutter.
