# Access Compliance Report Public Rights-of-Way (Curb Ramps)

Main Street: NEWLAND\_ST Cross Street: WASHINGTON\_AVE Location: NE

ADA ID: RPRK211001114809 Ramp Type: Type 1 - Perpendicular Diagonal Initial Pass/Fail: Fail Overall Compliance: No Severity Score: 2

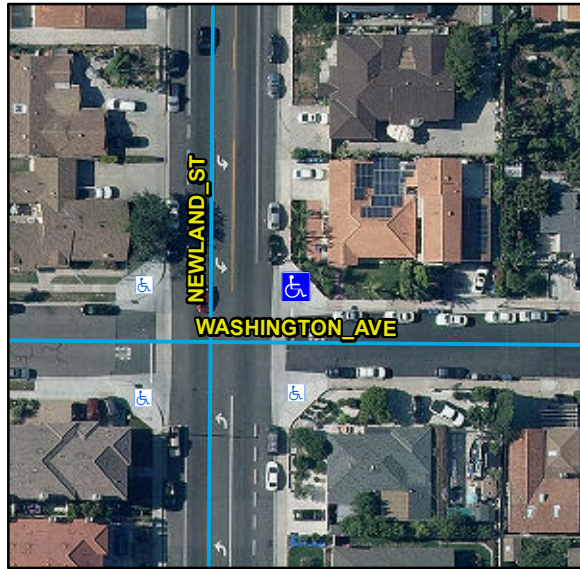
| Compliance | Description | Data | Compliance | Description | Data |
|---|---|---|---|---|---|
| No | Ramp Cross Slope (%) | 4 | N/A | Flare Traversable LT | N/A |

**Remove & Replace Curb Ramp With Two New Directional Ramps or Equivalent.**

**R304.2.2, R304.5.3, STD 1115**
