# Access Compliance Report Public Rights-of-Way (Curb Ramps)

Main Street: NEWLAND\_ST Cross Street: ROOSEVELT\_AVE Location: SW

ADA ID: RPRK211001133959 Ramp Type: Type 1 - Perpendicular Diagonal Initial Pass/Fail: Fail Overall Compliance: No Severity Score: 20

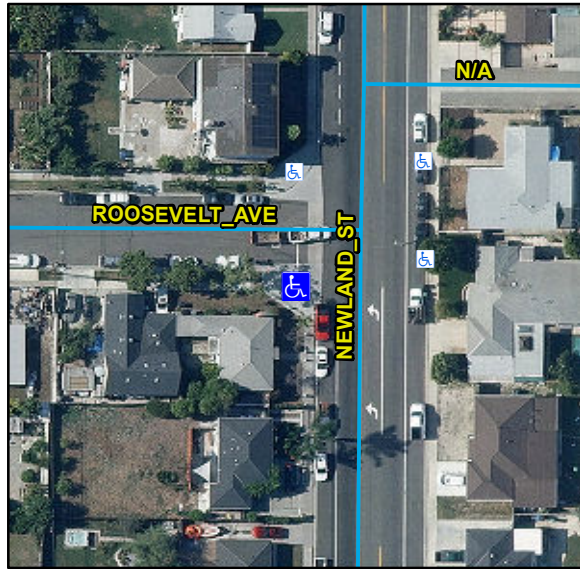
| Compliance | Description | Data | Compliance | Description | Data |
|---|---|---|---|---|---|
| No | Ramp Width (in) | 36 | | | N/A |
| No | Ramp Run Slope (%) | 11.3 | N/A | Flare Slope LT (%) | N/A |
| No | Ramp Cross Slope (%) | 4.4 | N/A | Flare Traversable LT | N/A |

**Remove & Replace Curb Ramp With Two New Directional Ramps or Equivalent.**

**R304.2.2, R304.5.1, R304.5.3, STD 1115**
