# Access Compliance Report Public Rights-of-Way (Curb Ramps)

Main Street: ROOSEVELT\_AVE Cross Street: NEWLAND\_ST Location: NW

ADA ID: RPRK211001134339 Ramp Type: Type 1 - Perpendicular Diagonal Initial Pass/Fail: Fail Overall Compliance: No Severity Score: 19

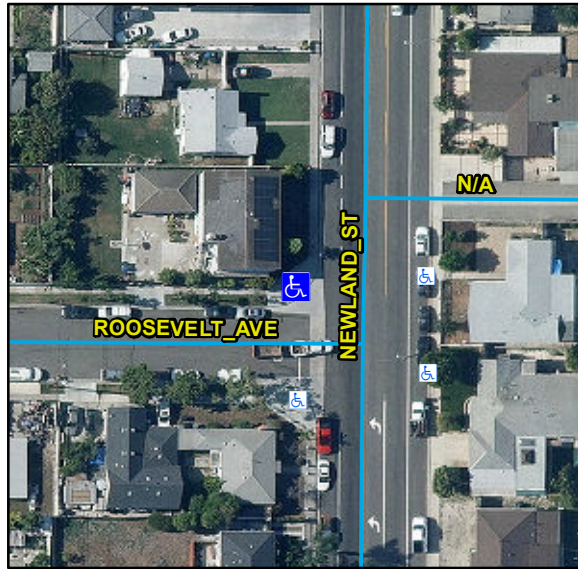
| Compliance | Description | Data | Compliance | Description | Data |
|---|---|---|---|---|---|
| No | Ramp Width (in) | 36 | | | N/A |
| No | Ramp Run Slope (%) | 9.9 | N/A | Flare Slope LT (%) | N/A |
| N/A | Gutter Ponding | N/A | No | Curb Slope | 11.5 |

**Remove & Replace Curb Ramp With Two New Directional Ramps or Equivalent.**

**R304.2.2, R304.5.1, STD 1115**
