# Access Compliance Report Public Rights-of-Way (Curb Ramps)

Main Street: HARPER\_ST Cross Street: ROOSEVELT\_AVE Location: NE

ADA ID: RPRK211001134721 Ramp Type: Type 1 - Perpendicular Diagonal Initial Pass/Fail: Fail Overall Compliance: No Severity Score: 4

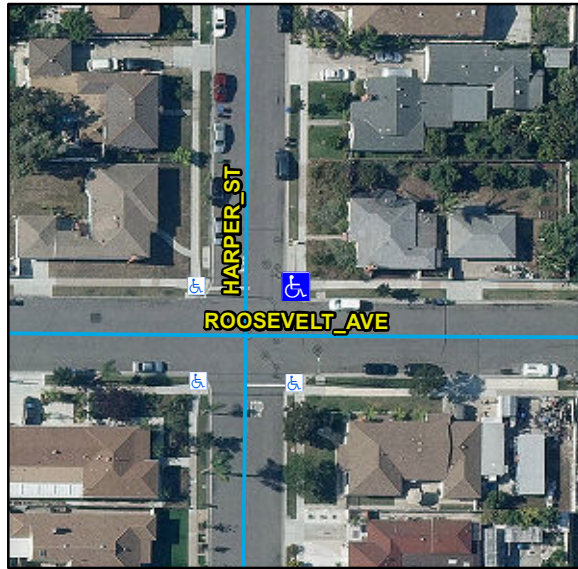
| Compliance | Description | Data | Compliance | Description | Data |
|---|---|---|---|---|---|
| No | Ramp Width (in) | 36 | | | N/A |

Remove & Replace Curb Ramp With Two New Directional Ramps or Equivalent.

R304.2.2, R304.5.1, STD 1115
