# Access Compliance Report Public Rights-of-Way (Curb Ramps)

Main Street: ROOSEVELT\_AVE Cross Street: HARPER\_ST Location: SE

ADA ID: RPRK211001135108 Ramp Type: Type 1 - Perpendicular Diagonal Initial Pass/Fail: Fail Overall Compliance: No Severity Score: 5

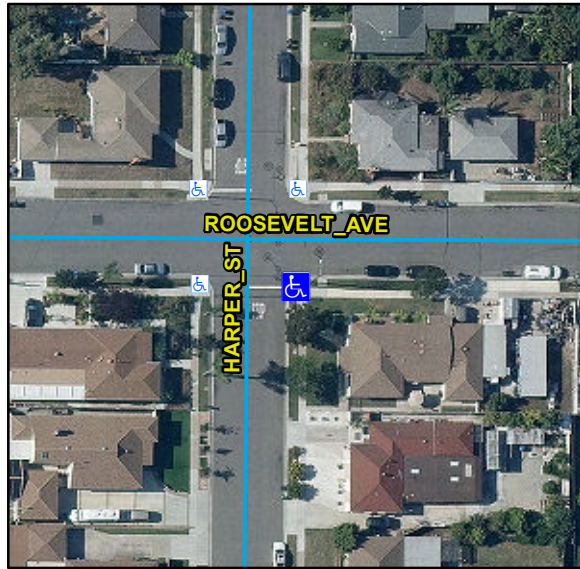
| Compliance | Description | Data | Compliance | Description | Data |
|---|---|---|---|---|---|
| No | Ramp Width (in) | 36 | | | N/A |
| No | Ramp Cross Slope (%) | 3.1 | N/A | Flare Traversable LT | N/A |

**Remove & Replace Curb Ramp With Two New Directional Ramps or Equivalent.**

**R304.5.1, R304.5.3, STD 1115**
