# Access Compliance Report Public Rights-of-Way (Curb Ramps)

Main Street: HARPER\_ST Cross Street: ROOSEVELT\_AVE Location: SW

ADA ID: RPRK211001135515 Ramp Type: Type 1 - Perpendicular Diagonal Initial Pass/Fail: Fail Overall Compliance: No Severity Score: 4

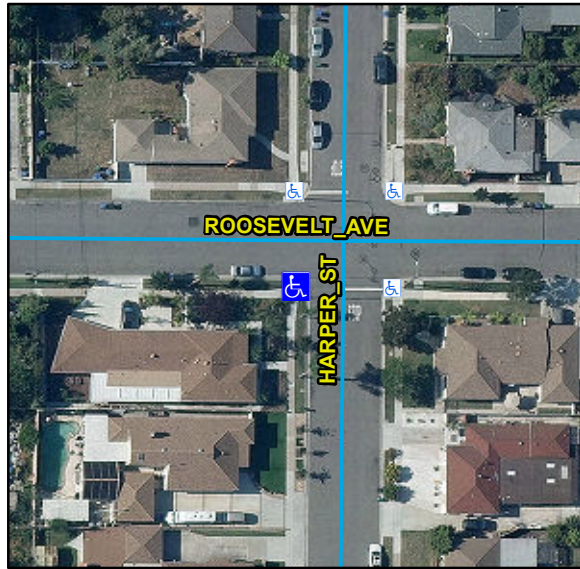
| Compliance | Description | Data | Compliance | Description | Data |
|---|---|---|---|---|---|
| No | Ramp Width (in) | 36 | | | N/A |

Remove & Replace Curb Ramp With Two New Directional Ramps or Equivalent.
