# Access Compliance Report Public Rights-of-Way (Curb Ramps)

Main Street: ROOSEVELT\_AVE Cross Street: HARPER\_ST Location: NW

ADA ID: RPRK211001135928 Ramp Type: Type 1 - Perpendicular Diagonal Initial Pass/Fail: Pass Overall Compliance: No Severity Score: 10

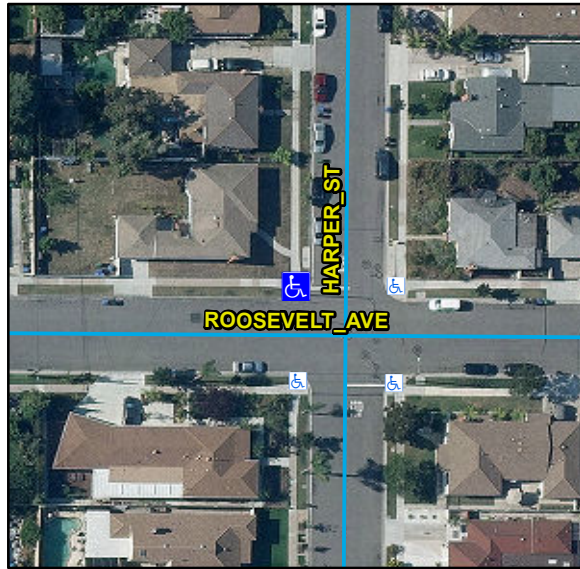
R304.2.2, R304.2.1, R304.2.2-Perp, R304.3.2-Para, R304.5.3, STD 1115

Remove & Replace Curb Ramp With Two New Directional Ramps or Equivalent.
