# Access Compliance Report Public Rights-of-Way (Curb Ramps)

Main Street: WILSON\_ST Cross Street: ROOSEVELT\_AVE Location: NE

ADA ID: RPRK211001140226 Ramp Type: Type 1 - Perpendicular Diagonal Initial Pass/Fail: Fail Overall Compliance: No Severity Score: 30

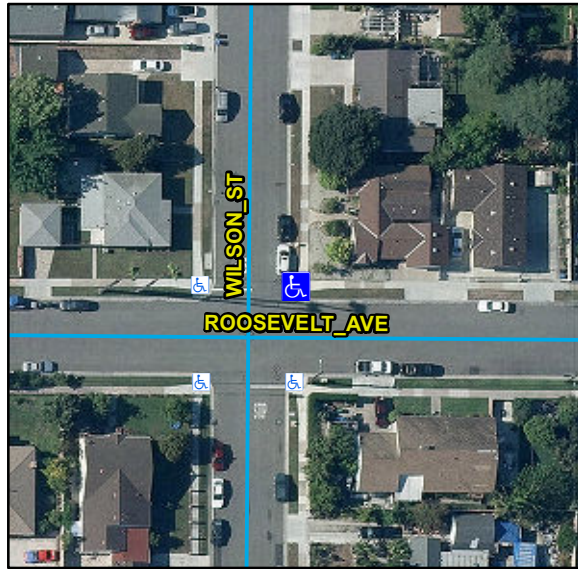
| Compliance | Description | Data | Compliance | Description | Data |
|---|---|---|---|---|---|
| No | Ramp Cross Slope (%) | 11.4 | N/A | Flare Traversable LT | N/A |
| N/A | Gutter Ponding | N/A | No | Curb Slope | 11.3 |

**Remove & Replace Curb Ramp With Two New Directional Ramps or Equivalent.**

**R304.2.2, R304.5.3, STD 1115**
