# Access Compliance Report Public Rights-of-Way (Curb Ramps)

Main Street: ROOSEVELT\_AVE Cross Street: WILSON\_ST Location: SE

ADA ID: RPRK211001140610 Ramp Type: Type 1 - Perpendicular Diagonal Initial Pass/Fail: Fail Overall Compliance: No Severity Score: 30

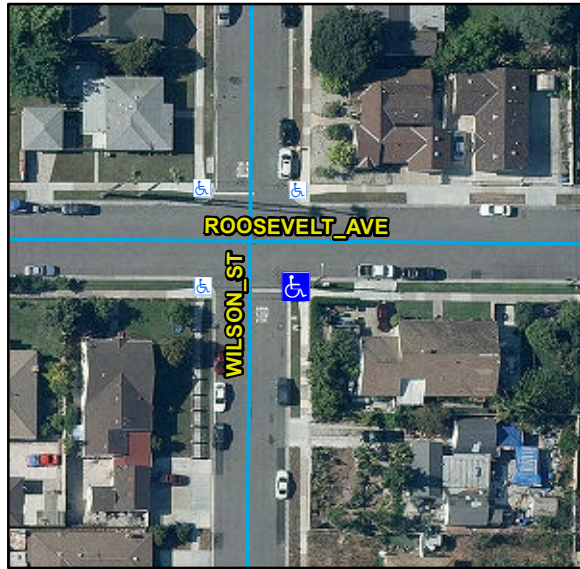
| Compliance | Description | Data | Compliance | Description | Data |
|---|---|---|---|---|---|
| No | Ramp Cross Slope (%) | 12.5 | N/A | Flare Traversable LT | N/A |
| N/A | Gutter Ponding | N/A | No | Curb Slope | 10.2 |

Remove & Replace Curb Ramp With Two New Directional Ramps or Equivalent.

R304.2.2, R304.5.3, STD 1115
