# Access Compliance Report Public Rights-of-Way (Curb Ramps)

Main Street: WILSON\_ST Cross Street: ROOSEVELT\_AVE Location: SW

ADA ID: RPRK211001140906 Ramp Type: Type 1 - Perpendicular Diagonal Initial Pass/Fail: Fail Overall Compliance: No Severity Score: 2

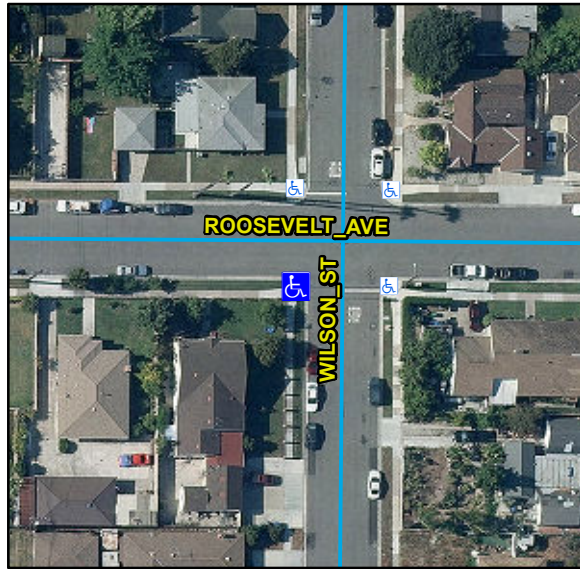
| Compliance | Description | Data | Compliance | Description | Data |
|---|---|---|---|---|---|
| No | Ramp Cross Slope (%) | 3.6 | N/A | Flare Traversable LT | N/A |

**Remove & Replace Curb Ramp With Two New Directional Ramps or Equivalent.**

**R304.5.3, STD 1115**
