# Access Compliance Report Public Rights-of-Way (Curb Ramps)

Main Street: ROOSEVELT\_AVE Cross Street: WILSON\_ST Location: NW

ADA ID: RPRK211001141309 Ramp Type: Type 1 - Perpendicular Diagonal Initial Pass/Fail: Pass Overall Compliance: No Severity Score: 10

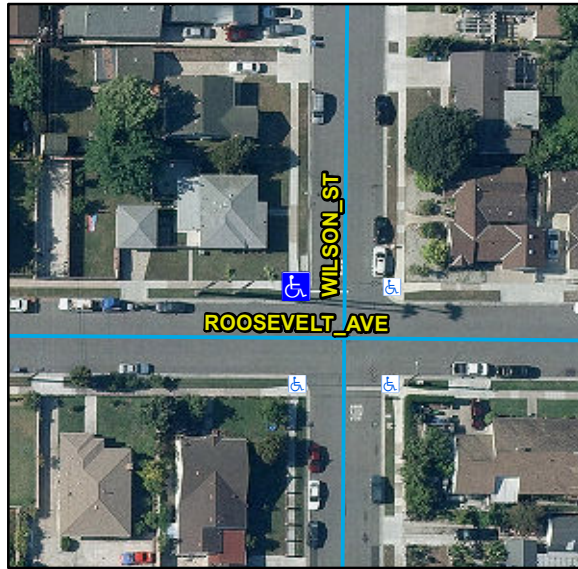
| Compliance | Description | Data | Compliance | Description | Data |
|---|---|---|---|---|---|
| N/A | Ramp Length (in) | 95 | N/A | Flare Type LT | |
| Yes | Ramp Width (in) | 48 | | | Sloped |
| Yes | Ramp Run Slope (%) | 4.8 | N/A | Flare Slope LT (%) | 4.9 |
| Yes | Ramp Cross Slope (%) | 1.9 | N/A | Flare Traversable LT | No |
| No | Landing Width (in) | N/A | N/A | Flare Slope RT (%) | 4 |
| No | Landing Run Slope (%) | N/A | N/A | Flare Traversable RT | No |
| No | Landing Cross Slope (%) | N/A | Yes | DWS Provided | Yes |
| Yes | Gutter Ponding | No | No | Curb Slope | 10.3 |
| No | Gutter Cross Slope (%) | 2.3 | | | |

Remove & Replace Curb Ramp With Two New Directional Ramps or Equivalent. Remove & Replace Gutter.

R304.2.2, R304.2.1, R304.2.2-Perp, R304.3.2-Para, R304.5.3, STD 1115
