# Access Compliance Report Public Rights-of-Way (Curb Ramps)

Main Street: JEFFERSON\_ST Cross Street: ROOSEVELT\_AVE Location: NE

ADA ID: RPRK211001142043 Ramp Type: Type 1 - Perpendicular Diagonal Initial Pass/Fail: Fail Overall Compliance: No Severity Score: 2

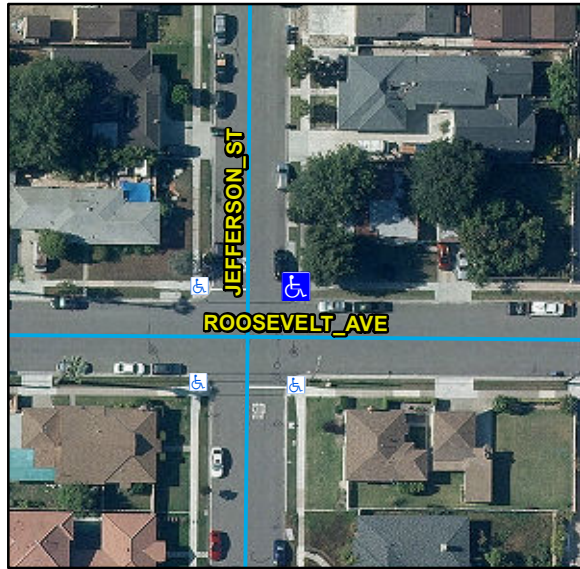
R304.2.2, R304.5.3, STD 1115

| Compliance | Description | Data | Compliance | Description | Data |
|---|---|---|---|---|---|
| No | Ramp Cross Slope (%) | 2.8 | N/A | Flare Traversable LT | N/A |

Remove & Replace Curb Ramp With Two New Directional Ramps or Equivalent.
