# Access Compliance Report Public Rights-of-Way (Curb Ramps)

Main Street: ROOSEVELT\_AVE Cross Street: JEFFERSON\_ST Location: NW

ADA ID: RPRK211001142256 Ramp Type: Type 1 - Perpendicular Diagonal Initial Pass/Fail: Fail Overall Compliance: No Severity Score: 2

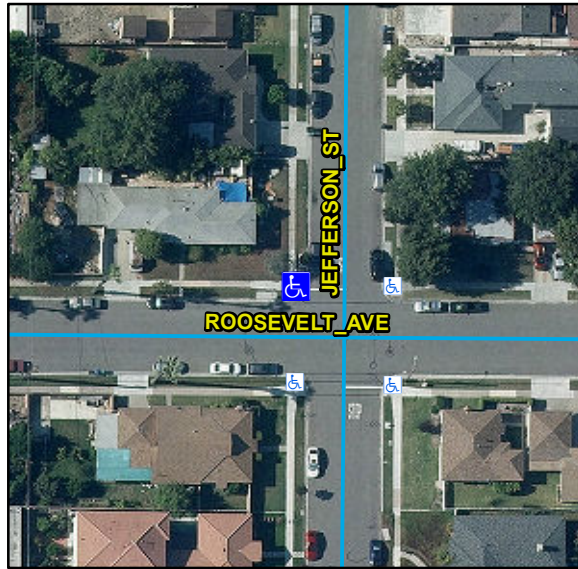
| Compliance | Description | Data | Compliance | Description | Data |
|---|---|---|---|---|---|
| No | Ramp Cross Slope (%) | 2.1 | N/A | Flare Traversable LT | N/A |
| N/A | Gutter Ponding | N/A | No | Curb Slope | 12.1 |

Remove & Replace Curb Ramp With Two New Directional Ramps or Equivalent.

R304.2.2, R304.5.3, STD 1115
