# Access Compliance Report Public Rights-of-Way (Curb Ramps)

Main Street: JEFFERSON\_ST Cross Street: ROOSEVELT\_AVE Location: SW

ADA ID: RPRK211001142451 Ramp Type: Type 1 - Perpendicular Diagonal Initial Pass/Fail: Fail Overall Compliance: No Severity Score: 2

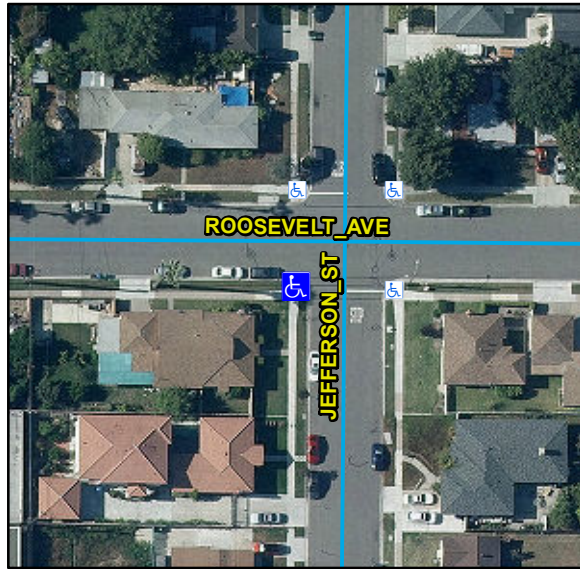
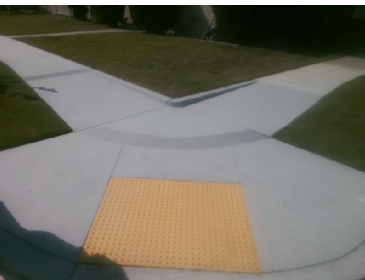
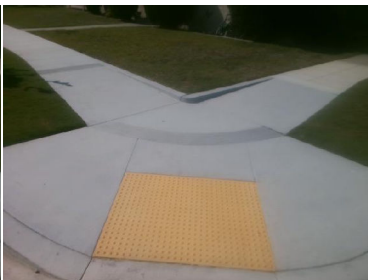
| Compliance | Description | Data | Compliance | Description | Data |
|---|---|---|---|---|---|
| No | Ramp Cross Slope (%) | 2.1 | N/A | Flare Traversable LT | N/A |

**Remove & Replace Curb Ramp With Two New Directional Ramps or Equivalent.**

**R304.5.3, STD 1115**
