# Access Compliance Report Public Rights-of-Way (Curb Ramps)

Main Street: JEFFERSON\_ST Cross Street: ROOSEVELT\_AVE Location: SE

ADA ID: RPRK211001142707 Ramp Type: Type 1 - Perpendicular Diagonal Initial Pass/Fail: Fail Overall Compliance: No Severity Score: 34

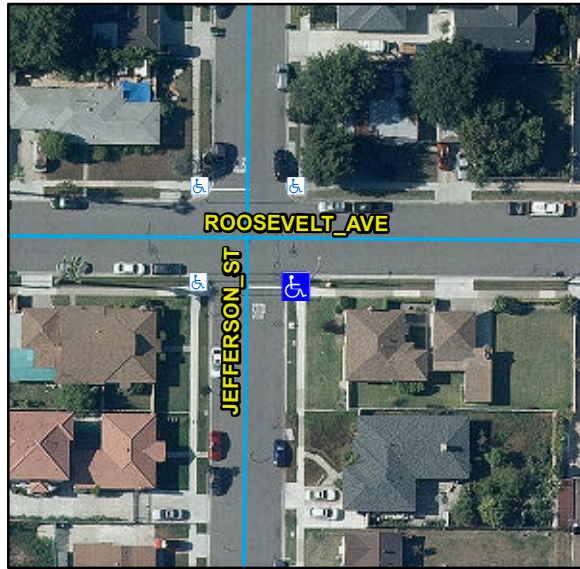
| Compliance | Description | Data | Compliance | Description | Data |
|---|---|---|---|---|---|
| No | Ramp Width (in) | 47 | | | N/A |
| No | Ramp Cross Slope (%) | 12.2 | N/A | Flare Traversable LT | N/A |

**Remove & Replace Curb Ramp With Two New Directional Ramps or Equivalent.**

**R304.2.2, R304.5.1, R304.5.3, STD 1115**
