# Access Compliance Report Public Rights-of-Way (Curb Ramps)

Main Street: VAN\_BUREN\_ST Cross Street: ROOSEVELT\_AVE Location: SW

ADA ID: RPRK211001143513 Ramp Type: Type 1 - Perpendicular Diagonal Initial Pass/Fail: Fail Overall Compliance: No Severity Score: 2

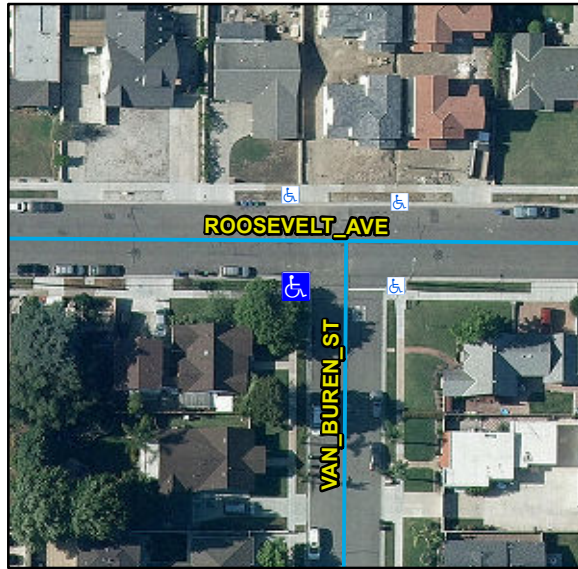
| Compliance | Description | Data | Compliance | Description | Data |
|---|---|---|---|---|---|
| No | Ramp Cross Slope (%) | 3.8 | N/A | Flare Traversable LT | N/A |

**Remove & Replace Curb Ramp With Two New Directional Ramps or Equivalent.**

**R304.5.3, STD 1115**
